Geotechnical Design and Restoration Challenges of a Distressed Pier at Sultan Yusuf Bridge

ABSTRACT

KEYWORDS: Underpinning, Bridge Restoration, Bored Pile, Micropile and Real Time Monitoring

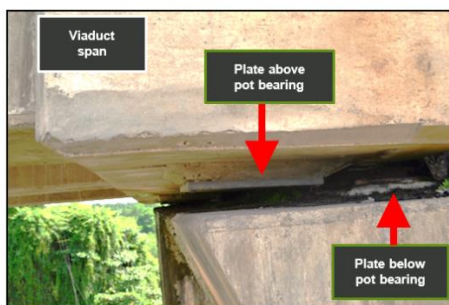
Figure 2. Pot Bearing Location

A significant 100mm drop of the viaduct deck, which was initially detected in July 2017 had triggered a detailed inspection of Pier 11. Further inspection of Pier 11 was carried out in August 2017, which provided an observation that the original pot bearing was fully damaged with the center support of the deck had shifted significantly to one side. The pot bearings beneath both viaduct span and box girder span were identified to be completely driven out from the original position as shown in Figure 2. The pier had been observed to be tilted and moved excessively toward the river direction, which led to the observation of severe damage and cracks on the pier column and pier crosshead beam. Figure 3 indicates an obvious drop of 100mm at the bridge and land viaduct connection. Figure 4 shows an aerial view of the dislodged position of Pier 11. Part of the pile cap was observed to be exposed which was likely due to the river erosion over the duration of 30 years. The loss of the soil passive resistance in front of the pile group (at the riverbank) would likely be one of the triggers to the movement.

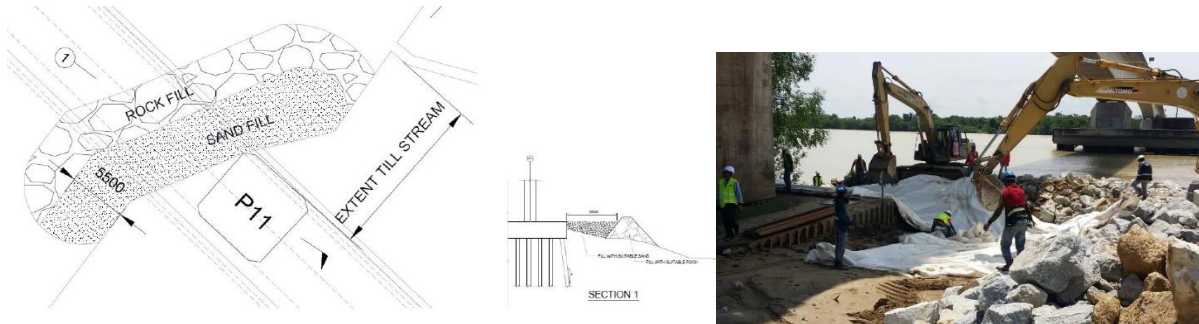
Figure 6. Sandbags and Rock Filling

The next step was to temporarily stabilize the riverbank and create passive resistance to Pier 11. This was done by using sandbags and rock filling at the riverbank in front of Pier 11. Analysis had been carried out on two (2) conditions; Condition 1- original eroded riverbank & Condition 2 - riverbank stabilized by sand and rock fill. The analysis results showed an increase of factor of safety (FOS) from 1.2 to 1.6. Illustration of the proposed filling is given in Figure 6.

However, the filling using rock fill and sandbags at site were not as ideal as the planning. Most of the sandbags and rock fill were washed away during the execution and the contractor was unable to obtain sufficient supplies due to the short notices. The pier movement was still moving at an alarming rate. Given the critical moment, the consultants proposed a solution of tying Pier 11 to multiple adjacent piers (Piers 8,9 & 10) using wire rope and chain block. Analysis was carried out to calculate the rope size and length. Figure 7 shows the layout and elevation of the wire rope solution.

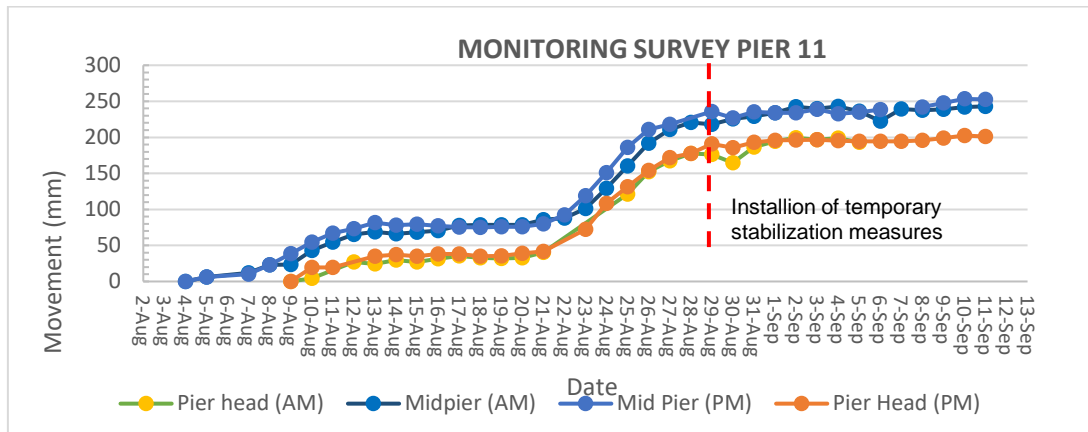
Figure 10. Manual Monitoring Data of Pier 11

Both the manual survey monitoring and real-time monitoring showed an active movement of Pier 11 towards the river. Manual readings taken from August 2017 to September 2017 (Figure 10) showed pier displacement at rate of 20mm/day within the final week of August 2017 while the real-time monitoring (Figure 11) at the pier head/diaphragm beam showed drastic increase of movement at the end of August 2017. The transducer T1 was found damaged due to the excessive movement of the diaphragm beam as shown in Figure 12. Once the temporary stabilization measures were in place in September 2017, it can be seen a rapid decreasing trend of pier movement. Due to the huge inconvenience of the bridge closure to the public, PWD and local council had asked the consultants to look into the possibility of opening the bridge in parallel to construction of permanent rectification. Several discussions and assessments had taken place among the consultants, and decision had been made to open the bridge to light vehicles on 30 December 2017.

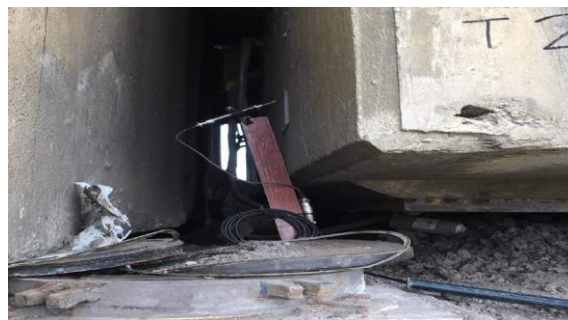
Figure 12. Damage of the Real-Time Transducer due to Excessive Movement

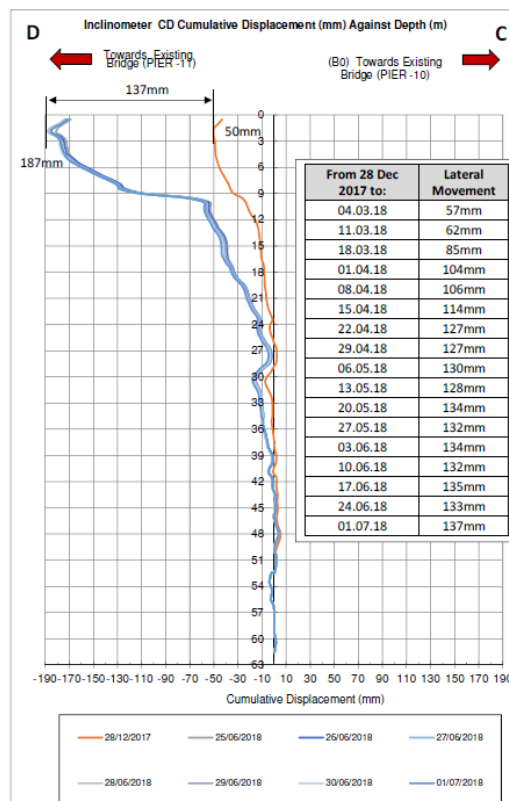
Figure 14. Inclinometer Readings

Figure 14 shows the total ground movement of 187mm towards the river over the duration of 8 months starting from 20 October 2017 where the maximum movement was recorded within the top 3m depth and the movement reduced with depth. For a duration of 6 months when the bridge was reopened to light traffic until the completion of the permanent support structure (end of June 2018), the ground was recorded moving 137mm towards the river.

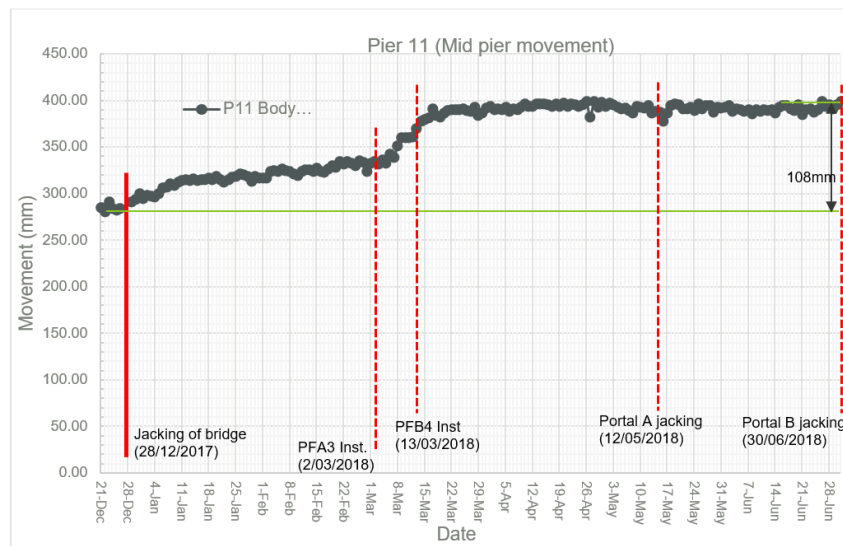
Figure 15. Pier Lateral Movement Graph

Figure 15 shows that Pier 11 had experienced progressive movement towards the Perak River. Interestingly, the movement had been gradual at a rate of about 0.6mm/day since the bridge reopened until early March 2018 where the permanent restoration foundation work commenced. During the restoration works, the pier movement rate had increased to 3.8mm/day which was an alarming rate. An emergency meeting was called, and consultant had proposed an adjustment to the permanent design. Further monitoring showed that the movement had stabilized, and the permanent restoration work continued as planned. A total movement of 108mm was recorded for the duration of 6 months.

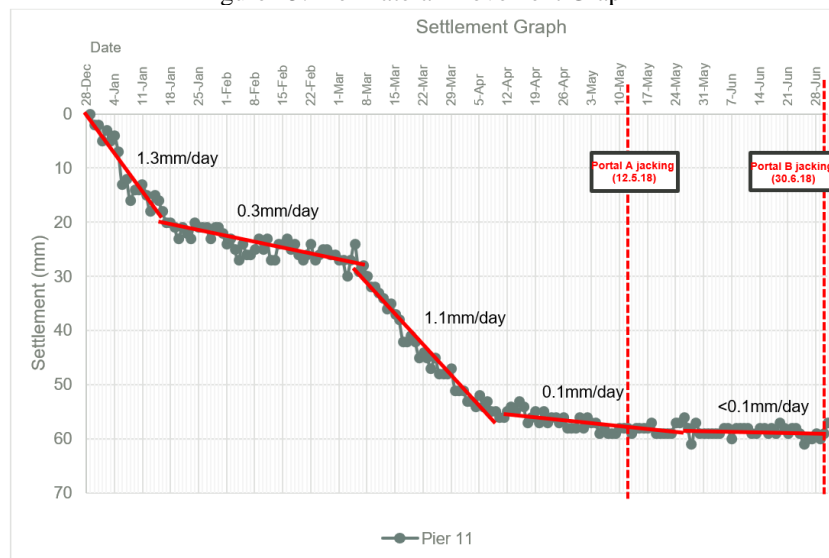
Figure 16. Pier Settlement Graph

In terms of settlement, Pier 11 was observed to experience quite an active settlement rate. As shown in Figure 16, high settlement was recorded in early January 2018 where the bridge was reopened to light vehicles and the bored pile foundation was in progress. In February 2018, the settlement rate had reduced to quite a nominal rate of 0.3mm/day before the rate increased to 1.1mm/day in March 2018. This is likely due to the construction work of permanent foundation for Pier 11. The settlement rate is seen to reduce to a nominal value of 0.1mm/day from April 2017 onwards.

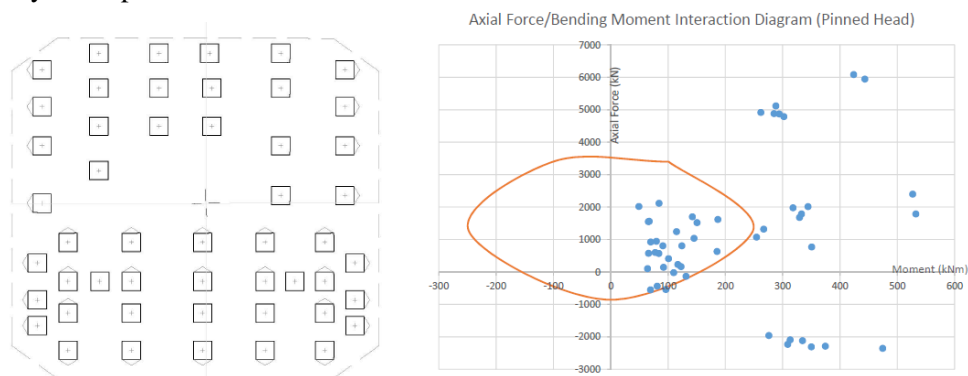
Figure 17. Assessment of the Existing Pile Group

The existing pile group consists of 50 numbers of reinforced concrete piles sized 385mm x 385mm. All the piles were reported being driven to 36m (unset). Based on the measurement of the pot bearing center line, it was assumed that Pier 11 had moved as much as 1.2m. Analysis had been carried out to establish the existing condition of the pile group. The analysis showed that about 50% of the existing piles were beyond the ultimate state condition and the pier was relying on the capacity of the balance 50%. Figure 17 shows the analysis output.

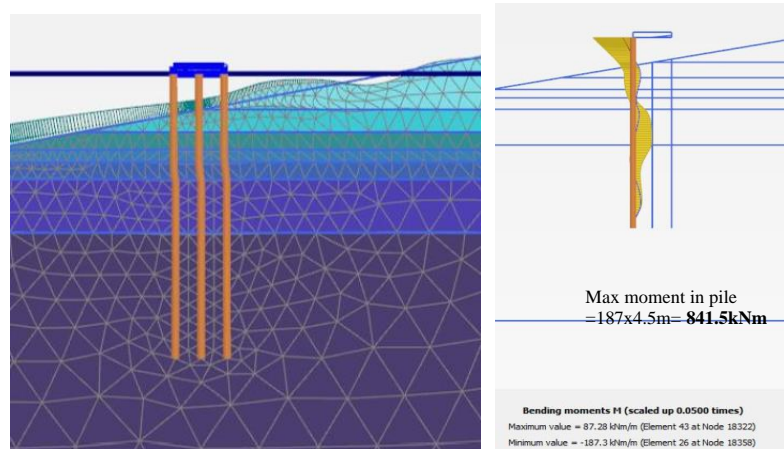
Figure 20. Finite Element Analysis Result

Analysis was carried out by considering the erosion of the riverbank. The bathymetric survey carried out showed that the slope beneath Pier 11 was badly eroded with steep inclination. The slope stability analysis carried out indicated a minimum factor of safety (FOS) of 1.20 which is lower than the allowable FOS of 1.30. This condition would likely induce lateral squeeze onto the new proposed foundation. Hence, the additional lateral squeeze force was calculated using Plaxis 2D finite element modelling where the output is shown in Figure 20. The analysis result was also cross-checked with the empirical approach based on Debeer & Walley (1972) method where an additional moment of 607kNm was calculated.

Both the finite element analysis and empirical approach produced additional moments, i.e. 841.5kNm and 607kNm respectively, due to the effect of lateral squeeze. A final value of 850kNm was adopted for the bending moment design. The foundation was then designed accordingly. The summary of the remedial foundation is given in Table 1.
