## Review on the difficult case of the pipe roof project to crossing National Highway no.1

In order to solve the local traffic problem, Construction Office New Taipei City Government planned to build a new road. Extending from Fude 2nd Rd to the north to Kangning Street, and using the pipe roof method (width 20.6m, height 10m, length 52m) to cross National Highway no.1 underground. However, there are existing 60cm diameter piles which under the retaining wall of National Highway No. 1. Due to the construction limitations of the pipe roof method, the existing piles must be removed before the advancement operation.

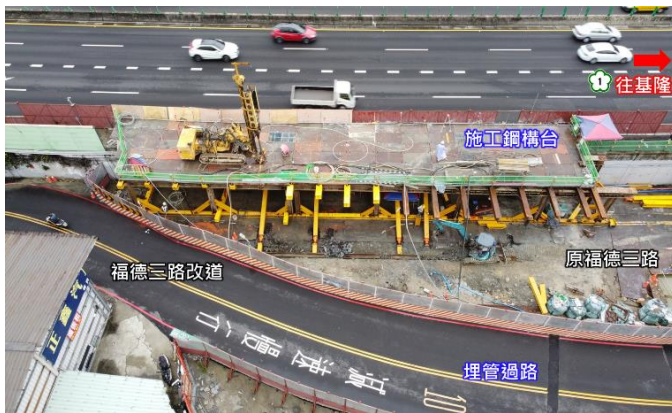
Figure 3. The Construction arrangement of ground improvement (1)

Limited by the size of highway construction space, it is necessary to set up additional construction steel structure platform for construction machinery and tools to walk. Since the Fude 3<sup>rd</sup> Road works area is also small, the mud pit (also known as decompression tank) required for high-pressure conversion can only be set in the road shoulder area. The construction machinery and tools are placed in the work area of TungHing Road, and the grouting pipe and water supply pipe of the two places have been connected through the road-buried pipe, as shown in FIG. 3 and FIG. 4.

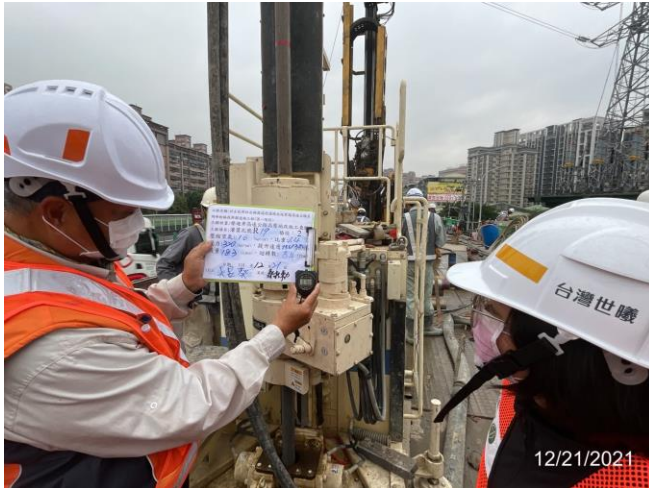
Figure 5. The Inspection of rod lift (Jet grouting method)

The construction process can be divided into the drilling stage and the grouting stage. In the drilling stage, whether it is the main hole or the decompression hole, the construction inspection must be carried out according to the hole coordinates, the bore diameter, the drill pipe Angle and the drilling depth. In the grouting stage, there are different inspection items and standards according to the Jet grouting methods and Double packer method, as detailed in Table 1 and Table 2. Refer to FIG. 5-8 for of on-site construction inspection photos.

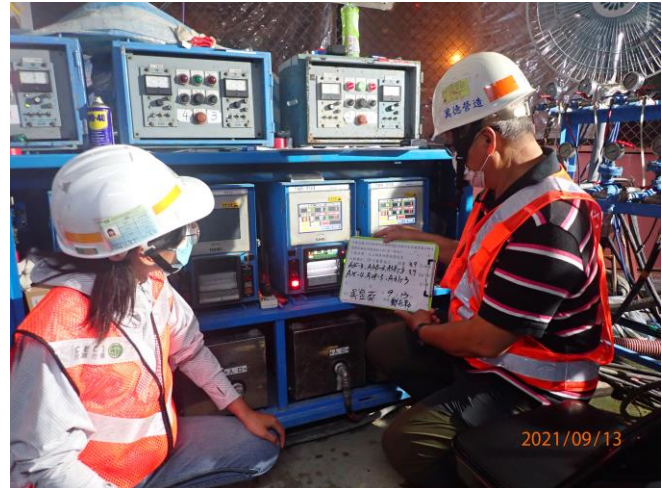
Figure 6. The Inspection of grout flow rate and pressure (Double packer method)

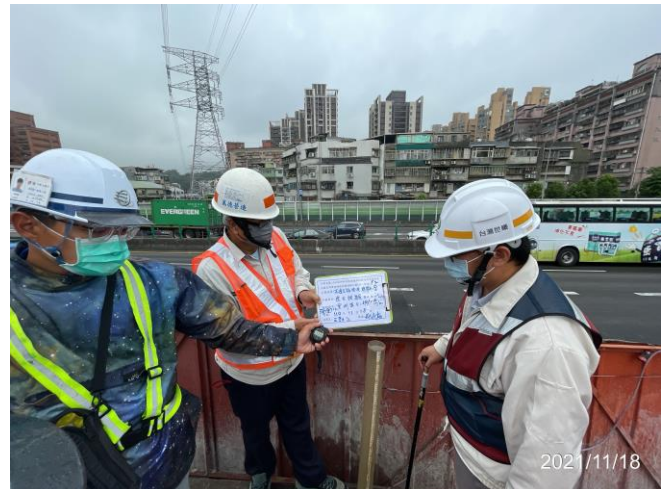
Figure 8. The in-situ falling head permeability test

Ground improvement results generally require an in-situ falling head permeability test ( $k \leq 10-5\text{cm/sec}$ ), core sampling, and uniaxial compression strength test. ( $q_u$ : clay  $\geq 10 \text{ kgf/cm}^2$ , sand  $\geq 20 \text{ kgf/cm}^2$ ). In order to strengthen the verification that the grouting pile can meet the design requirements, the test carried out the drilling verticality detection (SAA), the Pain bar test to measure the cut mark of steel pipe and the JWM pile diameter to measure the sound test simultaneously during the grouting construction process, so as to effectively grasp the construction results.

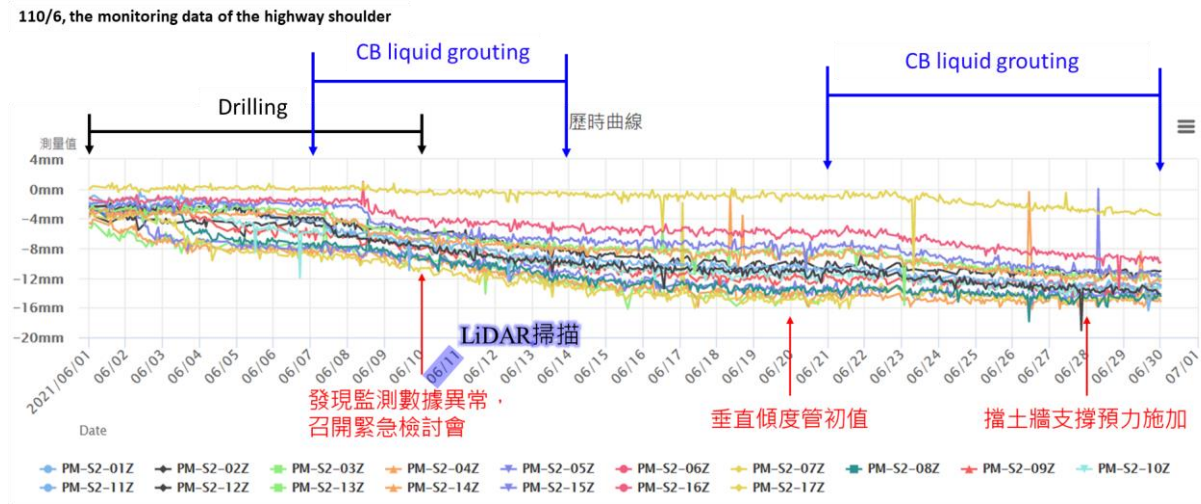
Figure 9(a). the monitoring data of the highway shoulder at 110/6

Through the monitoring results, it was found that during the initial drilling period, the shoulder of the highway had settled (FIG. 9(a)). After five days of drilling, the road settlement was 5.0mm. In the end, drilling caused the pavement to continue sinking, with a settlement of up to 16mm (FIG. 9(a)&9(b)).

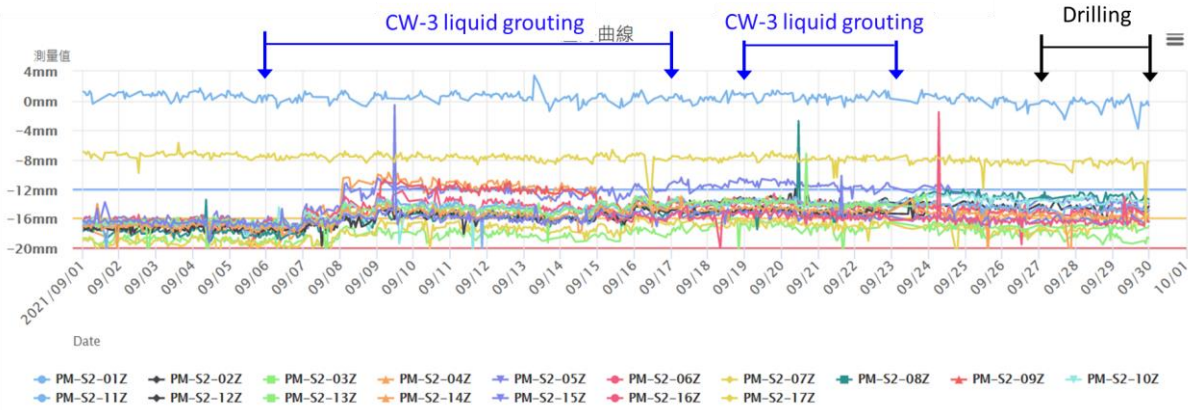
110/9, the monitoring data of the highway shoulder

Figure 9(c). the monitoring data of the highway shoulder at 110/9

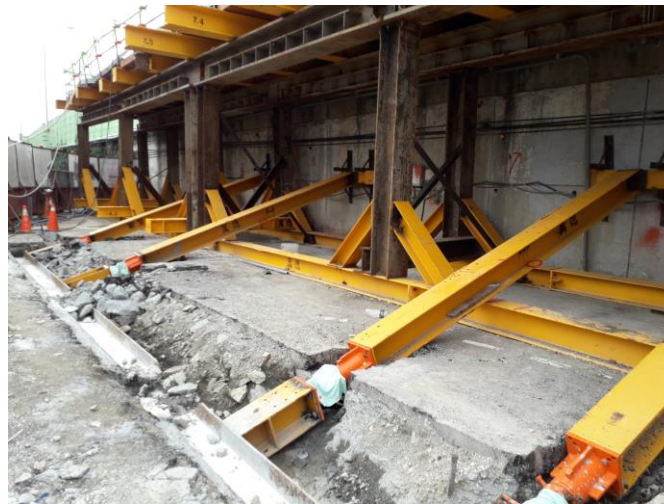
Figure 10. Retaining wall with added lateral support to control displacement

In general, local road settlement caused by drilling can be controlled by subsequent low-pressure grouting lift. However, the displacement of retaining wall affects the recovery of pavement subsidence by low-pressure grouting. Moreover, the grouting pressure estimation will cause the continuous displacement of the retaining wall, so the displacement of the retaining wall is suppressed by increasing the support.(FIG.10)

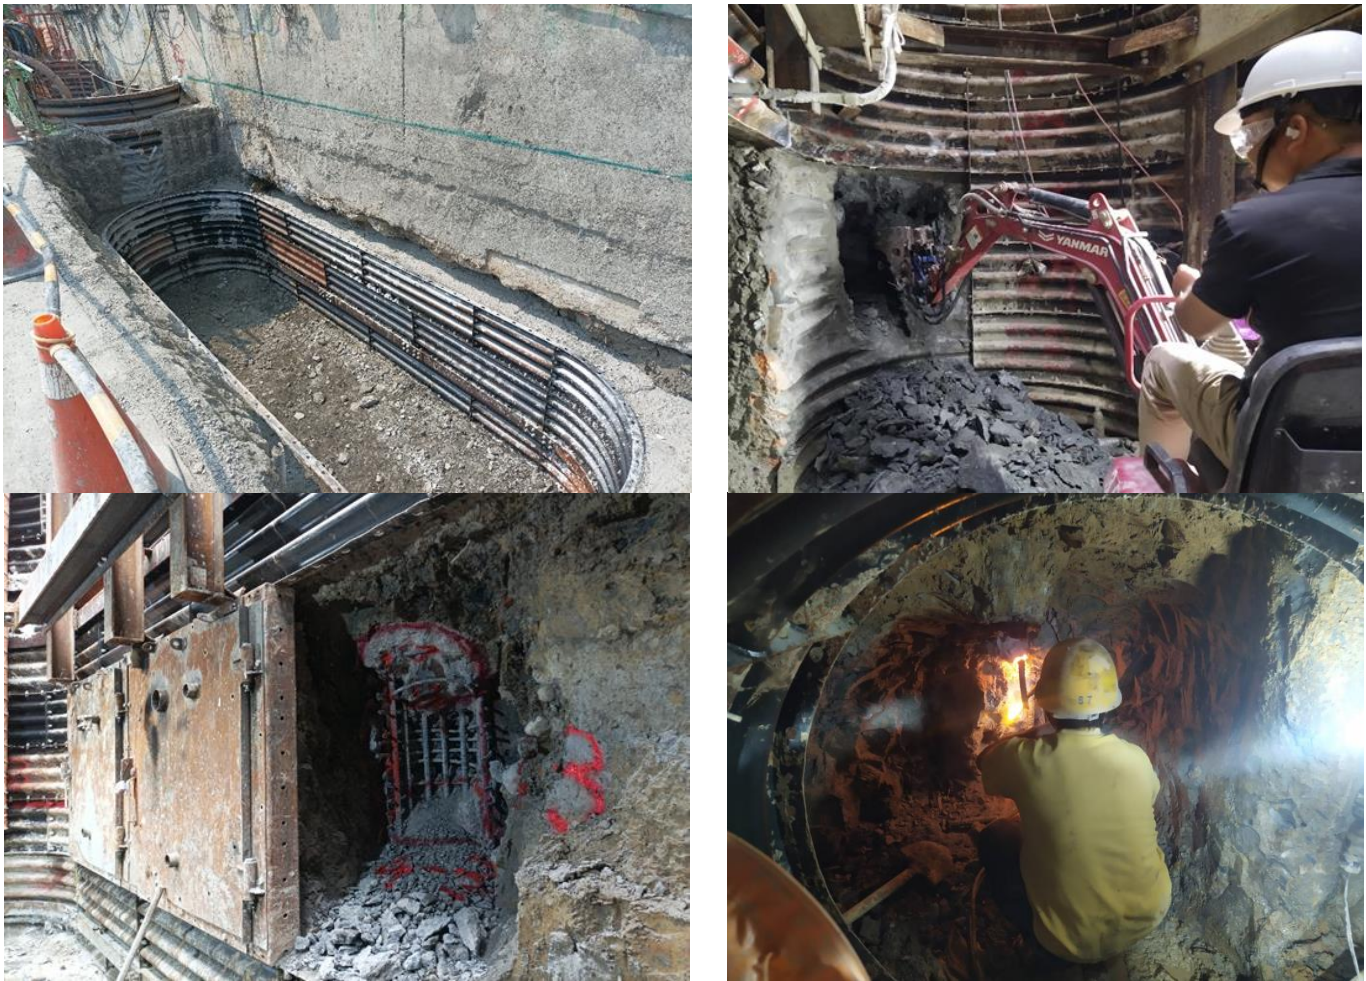
Figure 13. The photo of the foundation pile removed

Due to the limitation of the construction site, only small machines and tools can be used to support the manual work. In vertical excavation, four 2.1m\*6.8m elliptical steel lining plate is used as working wells. And supplemented with steel horizontal bracing, to carry out the excavation work for soil barrier construction. Lateral horizontal manual excavation with  $\phi$  1.2m circular steel lining plate as temporary protection. Considering that the ground improvement after excavation has been confirmed to be effective, the soil's self-supporting capacity is high. Therefore, the excavation of the vertical working well is canceled and replaced by oblique excavation. The adjacent foundation piles are broken by unsupported excavation. The construction photos show in FIG 13.
