Geotechnical Design and Restoration Challenges of a Distressed Pier at Sultan Yusuf Bridge

ABSTRACT

KEYWORDS: Underpinning, Bridge Restoration, Bored Pile, Micropile and Real Time Monitoring

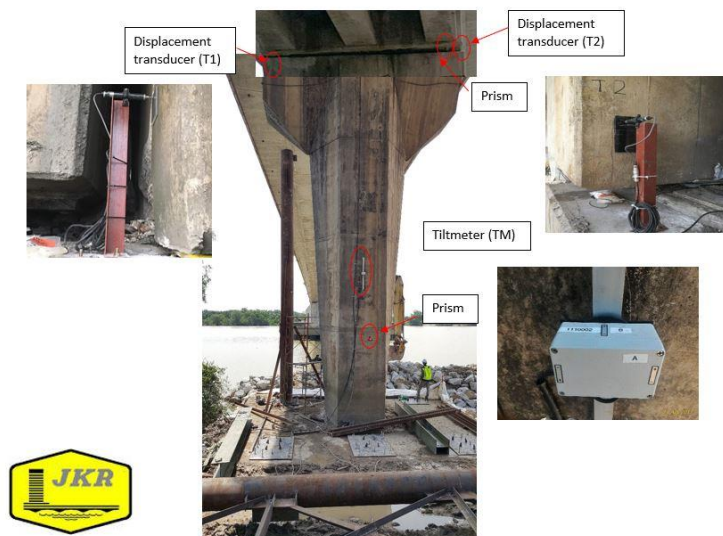
Figure 9. Position of Instrumentation Monitoring at Pier 11

Instrumentation monitoring had been proposed and installed almost immediately after the distresses were identified. Real-time monitoring and manual survey monitoring were carried out to monitor closely the Pier 11 condition while the consultants were working on the temporary remedial measures. The real-time monitoring installed were displacement transducers, tiltmeters and crack displacement transducers, while prisms were used for the manual survey using total station. The positions of the instrumentation are shown in Figure 9. During the critical moment, all the readings were taken daily.

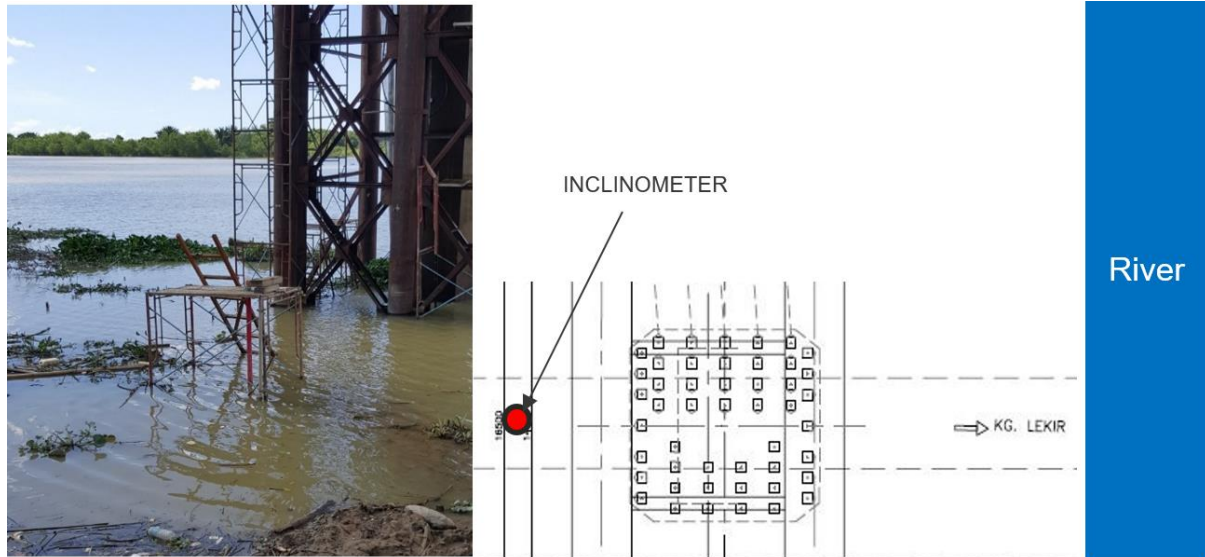
Figure 13. Location of Inclinometer in Reference to Pier 11

One (1) no of inclinometer was installed in front of Pier 11 for ground movement monitoring. Inclinometer is used to monitor the ground movement with depth. Readings were taken daily. The location of inclinometer is shown in Figure 13.

Figure 14 shows the total ground movement of 187mm towards the river over the duration of 8 months starting from 20 October 2017 where the maximum movement was recorded within the top 3m depth and the movement reduced with depth. For a duration of 6 months when the bridge was reopened to light traffic until the completion of the permanent support structure (end of June 2018), the ground was recorded moving 137mm towards the river.

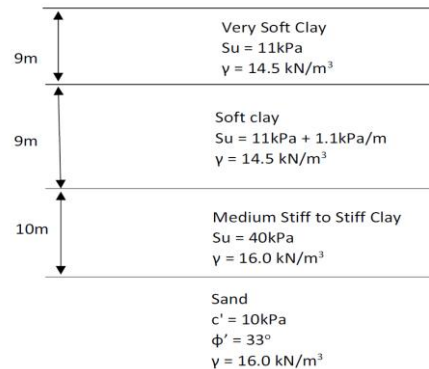
Figure 19. Soil Layers and Parameters

Prior to the design, 2 nos of additional boreholes were carried out to 90m depth to obtain the subsoil profiles and soil parameters. The interpretation of the soil stratification and parameters is shown in Figure 19.

Analysis was carried out by considering the erosion of the riverbank. The bathymetric survey carried out showed that the slope beneath Pier 11 was badly eroded with steep inclination. The slope stability analysis carried out indicated a minimum factor of safety (FOS) of 1.20 which is lower than the allowable FOS of 1.30. This condition would likely induce lateral squeeze onto the new proposed foundation. Hence, the additional lateral squeeze force was calculated using Plaxis 2D finite element modelling where the output is shown in Figure 20. The analysis result was also cross-checked with the empirical approach based on Debeer & Walley (1972) method where an additional moment of 607kNm was calculated.
